U.S. DEPARTMENT OF ENERGY
OFFICE OF FOSSIL ENERGY
NATIONAL ENERGY TECHNOLOGY LABORATORY

SENSORS TO DETECT CORROSION

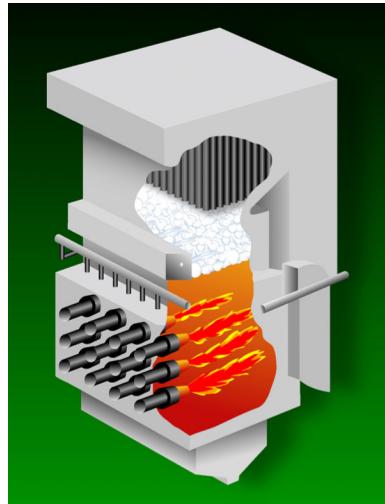
Schematic of a coal-fired boiler showing the burners (lower section) and the waterwall area above the burners.

Ash deposition occurs in the waterwall and superheater sections of coal combustors, as well as in the gasification and syngas cooler sections of coal gasifiers. This ash contains not only the unburned or unreacted portions of the coal but also sulfur- and chlorine-containing compounds formed in the energy conversion process. These deposits are usually solid but very often become molten, causing significant corrosion degradation of metallic materials used in power production facilities. At the present time the only way to detect corrosion problems is by cleaning during scheduled or unscheduled downtime periods.

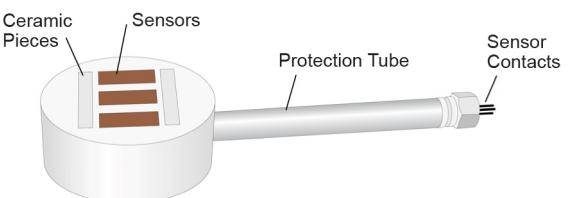
Schematic of electrochemical corrosion rate sensor.

Researchers at NETL have been studying the use of corrosion sensors based on electrochemical methods. Such sensors typically have three metallic elements (also called electrodes) and use the ash deposits as the electrolyte. The use of techniques such as linear polarization resistance, electrochemical noise, and harmonic distortion analysis provides measurement of corrosion rates and the probability of localized attack.

Variations on this sensor design have included:

- Thermally-cooled sensors to impart a thermal gradient and/or to simulate field use.
- Multi-element (9 element) sensors to increase sensitivity in low conductivity electrolytes.
- Multi-sensors containing two or three complete 3-element sensors to allow the study of different materials or different ashes in the same experiment.
- Rugged field sensors for industrial applications.

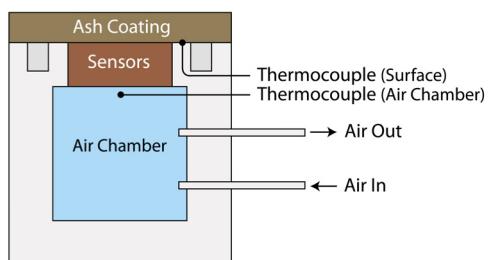
Schematic of a thermally-cooled sensor.

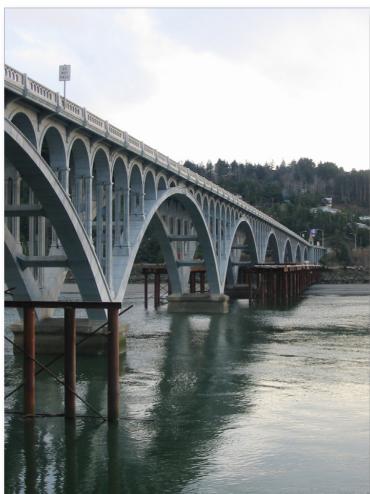
Patterson Bridge over the Rogue River in Gold Beach, Oregon.

The same technology used here for high temperature energy conversion applications has been used in the past to detect corrosion problems occurring in natural gas transmission pipelines (see photo at right). It is also being used to measure the corrosion rates of rebar and control impressed current cathodic protection of one of the steel-reinforced concrete bridges on the southern Oregon Coast (see photo at left).

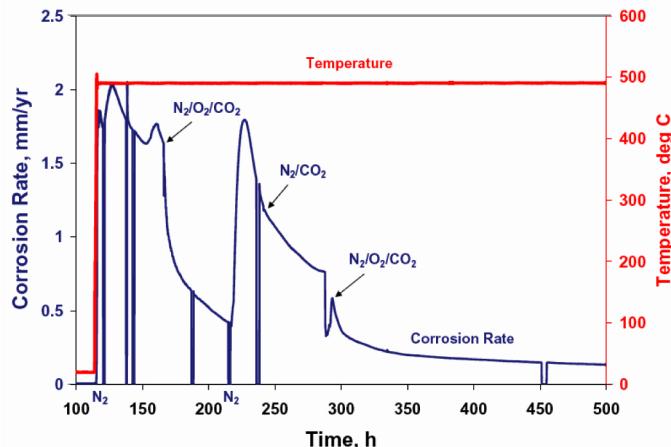
Effect of changing gas composition on the corrosion rate measured using an electrochemical corrosion rate sensor.

Research on these corrosion sensors shows that they are sensitive to changes in corrosion rate caused by changes in temperature, gas composition, and water vapor.

Corrosion rates measured with the corrosion sensors in laboratory experiments are always calibrated against a corrosion rate determined from mass loss samples exposed in the same experiment. This part of the research has shown that the electrochemical-based sensor typically measures lower corrosion rates than actually occurs. This means that the corrosion rates measured using the corrosion sensors are semi-quantitative. Research is currently underway to attempt to explain this and also to determine calibration factors that will make the measurements quantitative.

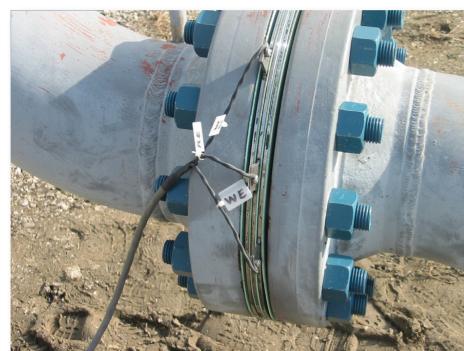
Flange corrosion sensors installed in an 8-inch natural gas transmission pipeline.
